Spreader bar and Sling Testing

Case Study

Profilage Ltd

Time Frame: 2023

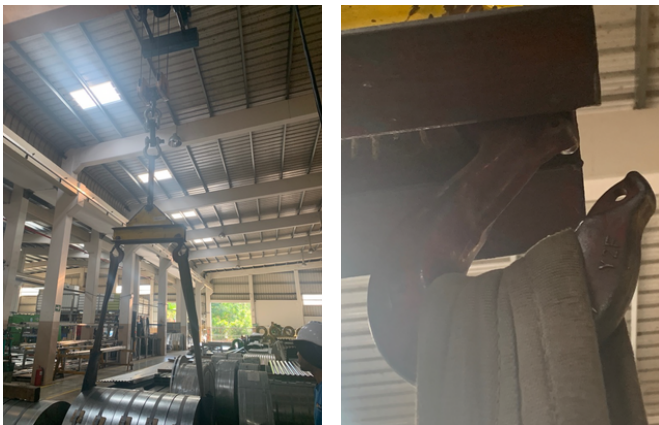
Pictures from Spreader Bar testing

As the spreader bars were made locally, the load test was carried out at 1.2x working load. Although the design load for the slings were known, the test was carried out at 1.2x working load

All spreader bars tested were found to be suitable for usage. A few slings were replaced by new ones immediately and certificates were issued.
